MDC SAMPLING MEMORANDUM

To: Sally Nyren
From: Amy Velasquez  
Date: September 24, 2009
C: Marc Nettleton
Subject: Summary of Samples Collected & Analytical Results for Nepaug Dam Caulk & Concrete

Nepaug Dam Caulk Samples

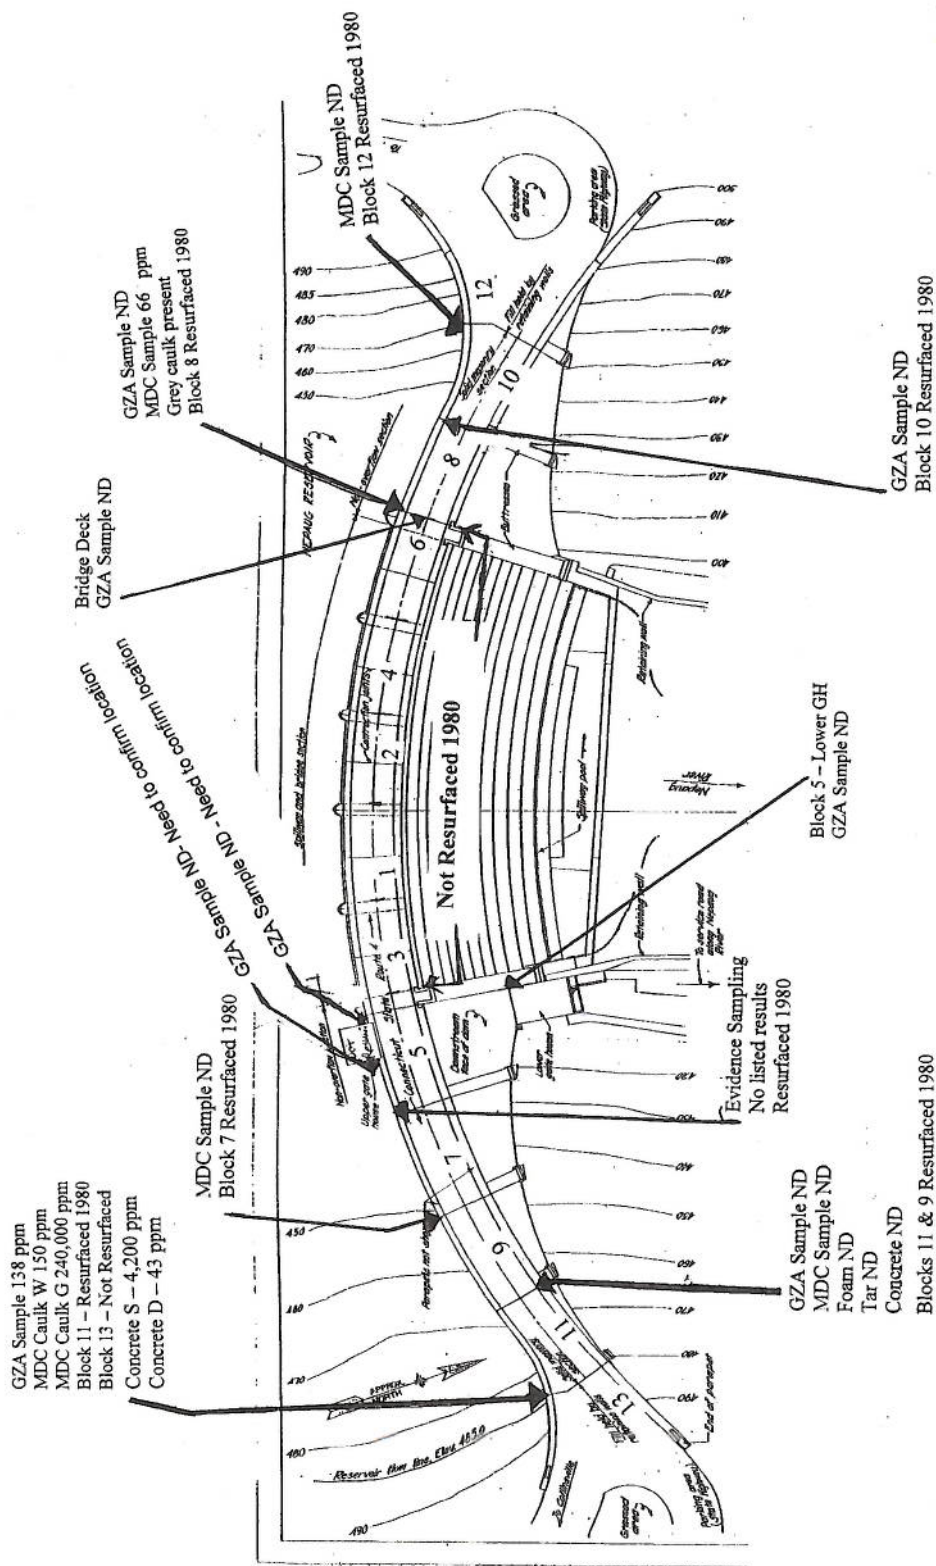
was sampled. Visual evidence indicated a previous sample had been collected from joints 5-7, 9-11 and 8-10. Previous sampling of joint 6-8 could not be confirmed because a large quantity of caulk was missing from the joint and no obvious knife marks were seen. The dam was spilling during this visit making it unsafe to inspect the upper gatehouse and joint 3-5 so information regarding those sampling points is currently unavailable. The GZA and MDC sample locations and corresponding analytical results are summarized on the attached drawing.

The grey caulk appears to be the source of the PCBs as indicated by the 240,000 ppm concentration detected in the grey caulk from joint 11-13. The grey caulk is present in joints connecting blocks

resurfaced in 1980 with blocks that were not resurfaced at that point (see attached drawing). In other words places where older concrete meets newer concrete. The grey caulk may also be present in joints between two blocks of older concrete (joints 3-5, 1-3, 1-2, 2-4 and 4-6) GZA indicated they sampled joint 3-5 and PCBs were not detected in that sample but we cannot be sure the grey caulk is not there until the joint is inspected by the MDC.

Blocks 11, 9, 7, 5, 8, 10 and 12 were resurfaced in 1980 and the caulk in joints between these blocks was removed. There should not be any 1974 caulk remaining between these blocks and therefore no source of PCBs. The only exception is, as stated above, where block 11 and block 8 meet up with blocks 13 and 6, respectively, which were not resurfaced in 1980.

Based on the current theory that the grey caulk placed prior to 1980 is the source of the PCBs, the preliminary remedial plan is to remove caulk at joints not included in the 1980 resurfacing work (joints 11-13, 6-8, 4-6, 2-4, 1-2, 1-3, and 3-5) where the caulk may potentially contain PCBs.
